# **Phase II Technical Feasibility Study of the Geothermal Capability of the Penobsquis Mine Site, Penobsquis, NB**

**Final Report  
TE183037**

**Town of Sussex**

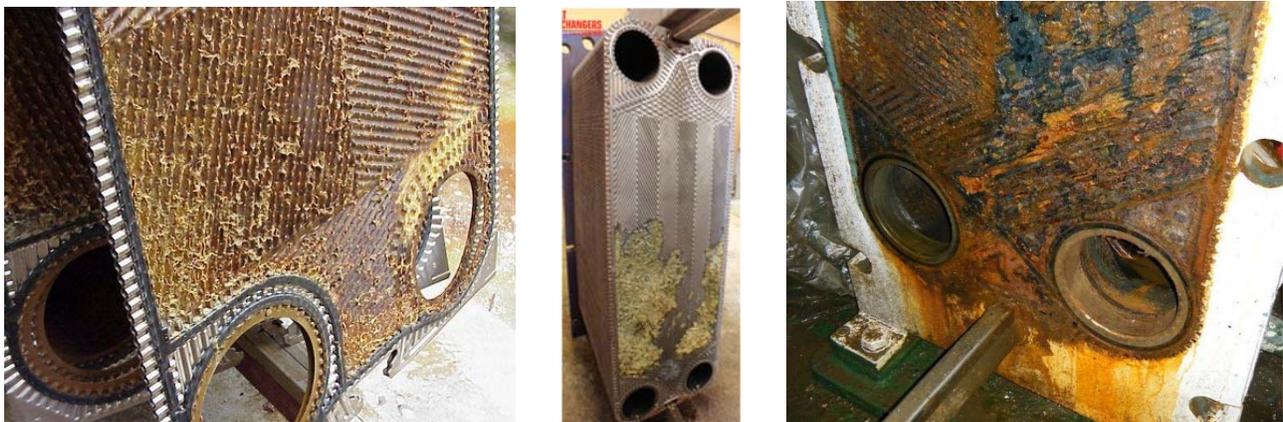
**Figure 1**      **Scaling on Frame and Plate Heat Exchangers**

Fouling causes build ups and damages within the HX; it reduces the fluid flow, and causes pressure and temperature issues, which lead to a decrease in thermal efficiency and overall functionality of the HX.

Depending on the chemistry of the water, fouling can occur which can compromise the integrity of the HX. Fouling is the accumulation of material on the heat transfer surface, which leads to a decrease in thermal efficiency of the HX. Different types of fouling can occur in a HX, including: scaling, particulate fouling, biological growths, and corrosion.

The material which builds up on the HX due to fouling has a lower conductivity than the plates, which causes thermal resistance to increase and heat transfer to decrease. Even so much as  $\frac{1}{16}$  of an inch of scaling can reduce the heat transfer ability in such a way that is equivalent to adding 3 inches of steel between the plates ("Sum-Kool"). The build-up also causes a change in the surface roughness which impacts the heat transfer ability and velocity of the fluid.
